On Site Photos

New Orleans, Louisiana

Wednesday, December 29, 2021

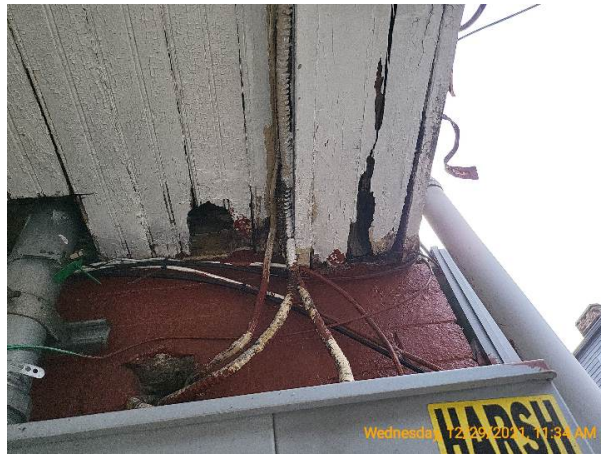
Sidewalk overhang has a negative slope across the front

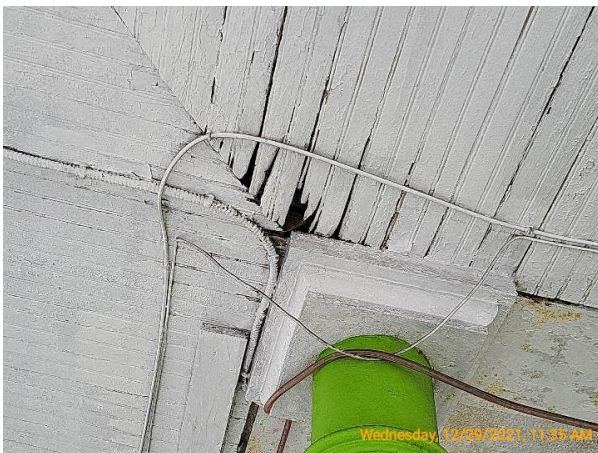
Overhang lighting was not functional

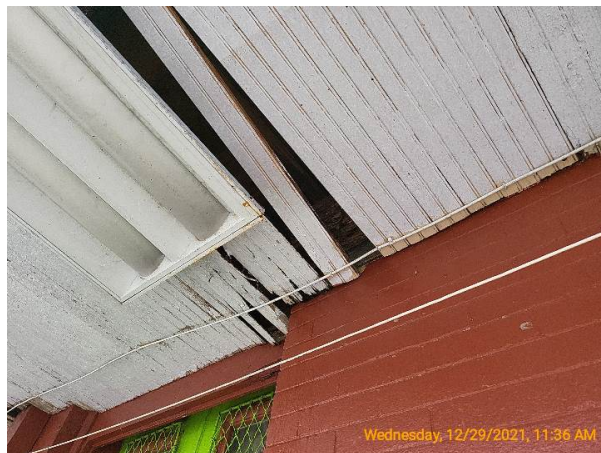
Significant wood rot below the sidewalk overhang

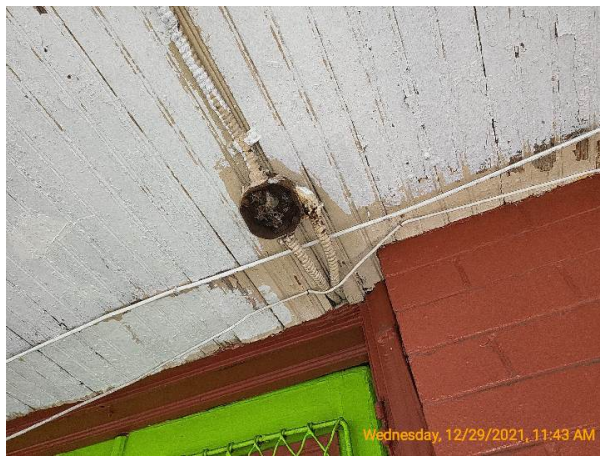
Significant wood rot below the sidewalk overhang

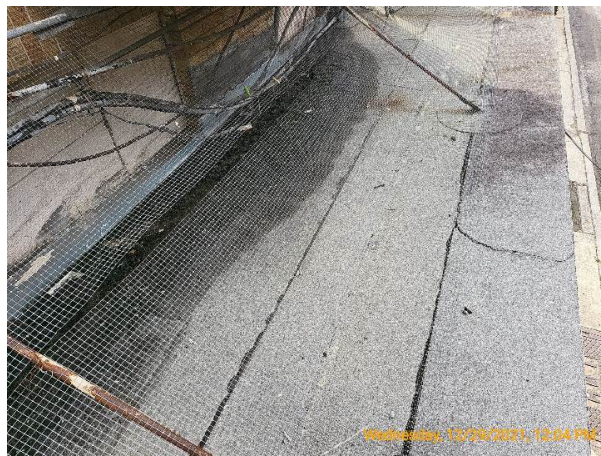
Representative failing roof at all balconies

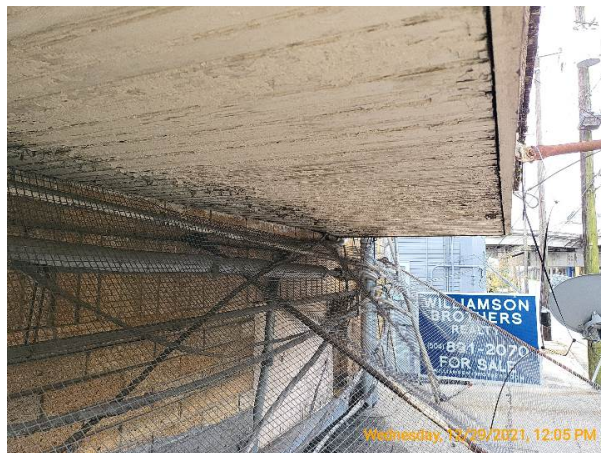
Close-up

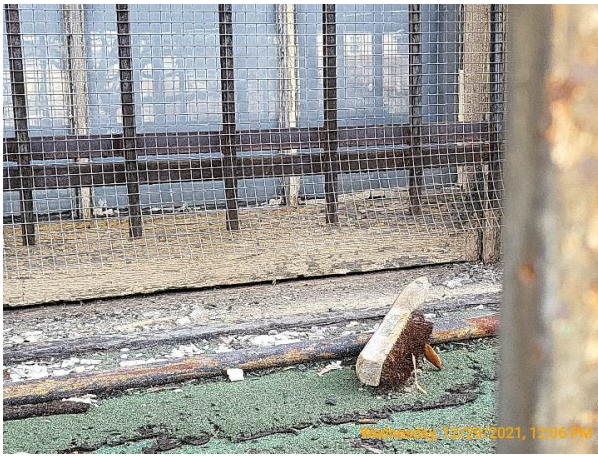
Severe wood rot and moisture staining below a front balcony

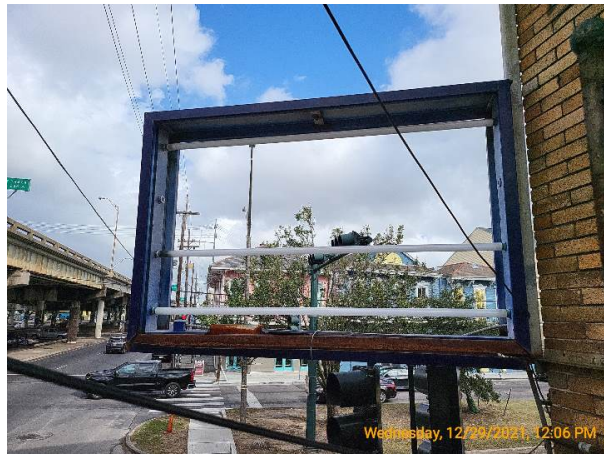
Significant glazing cracking and paint flaking at the windows

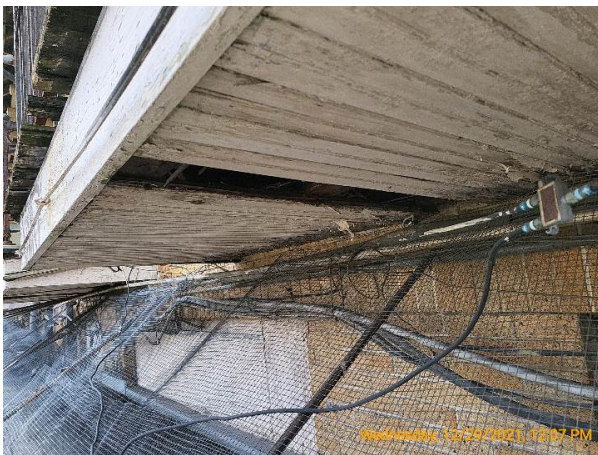
All balcony roofs are in poor condition

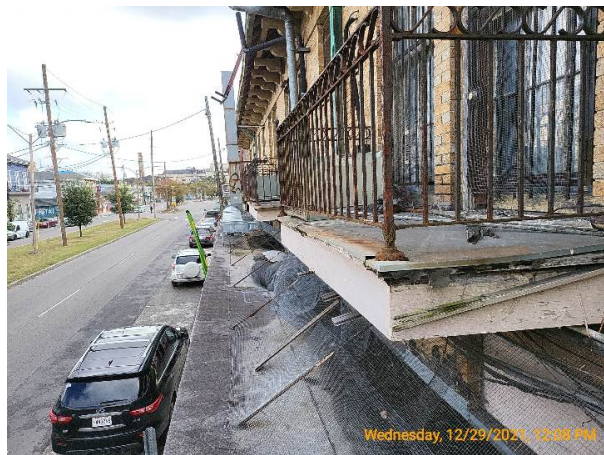
All balcony roofs have severe wood rot and moisture staining below them

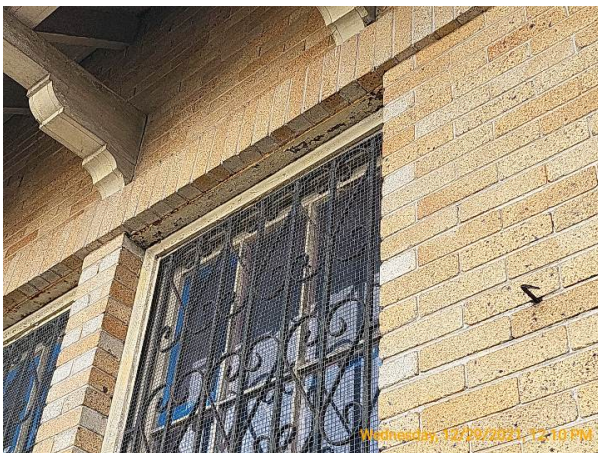
A left side balcony is notably out of square and structurally failing

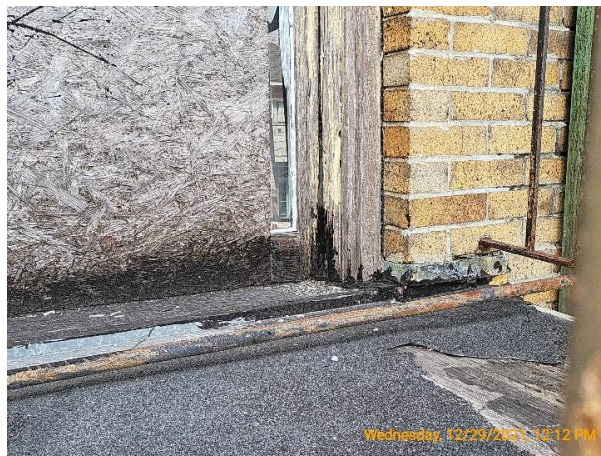
Missing window pane

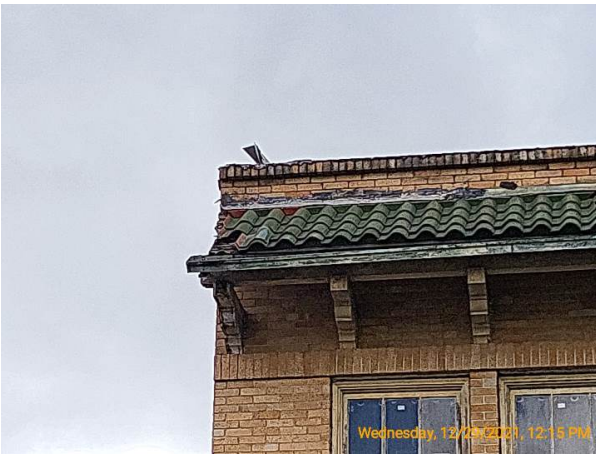
Upper roof soffit rot

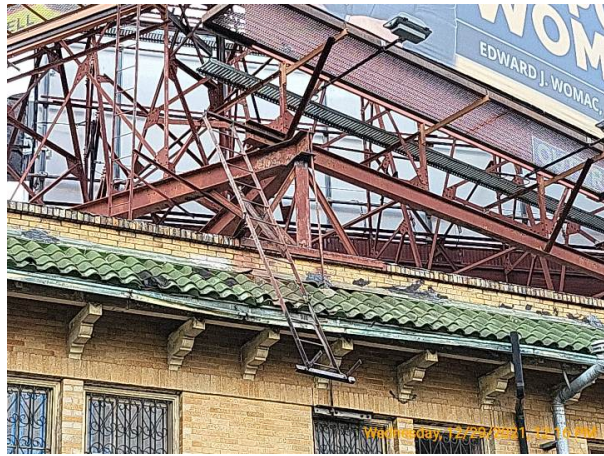
Terracotta tile roof failing around the left and front of the building

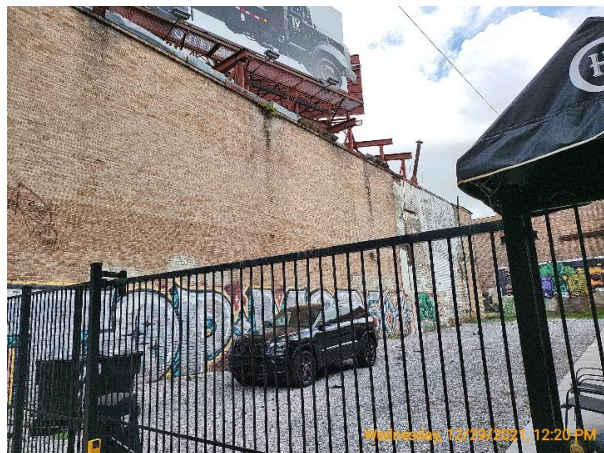
Metal parapet cap along the right side are bent upwards and significantly damaged

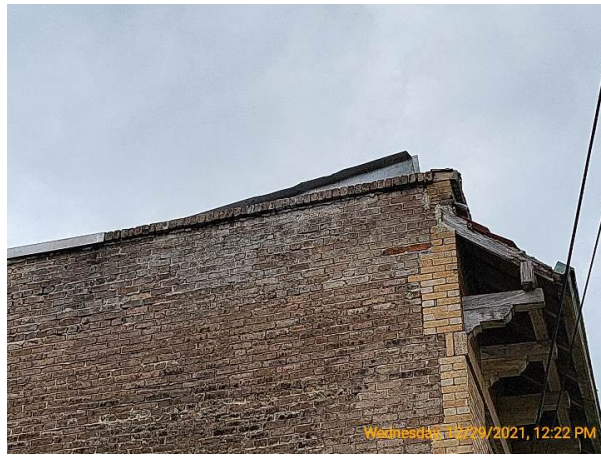
Numerous holes in the mortar were noted along the right side

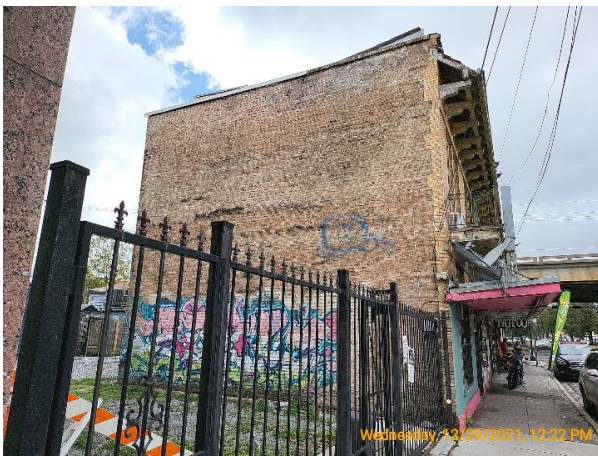
Parapet cap missing along most of the building

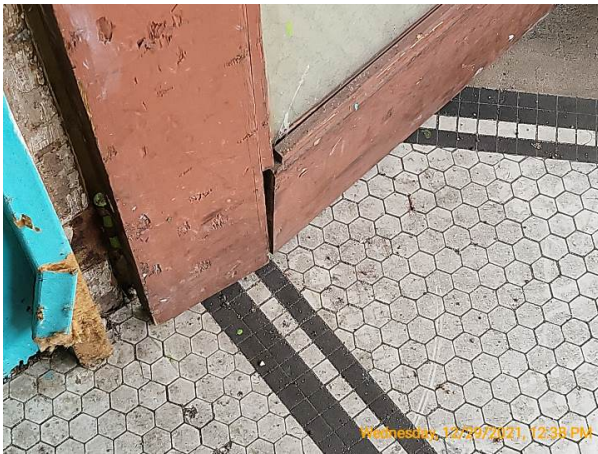
The door is difficult to open and close

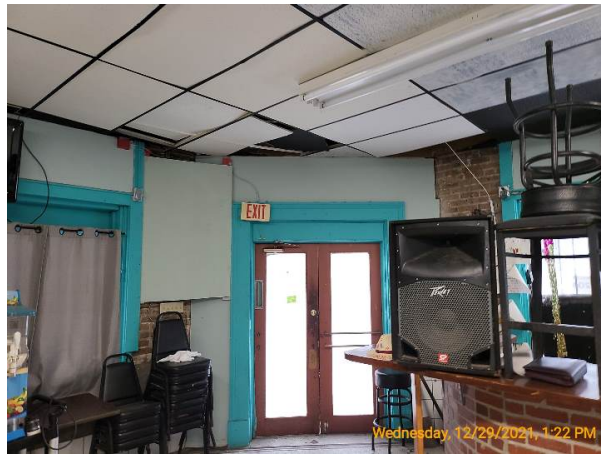
Same door significantly damaged at the bottom

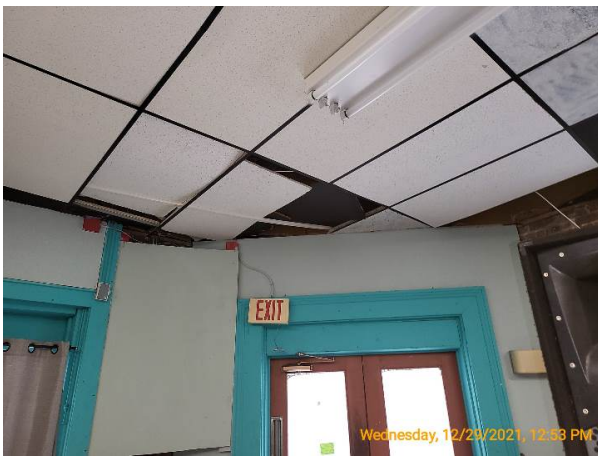
Inoperable emergency exit lighting for unit 714

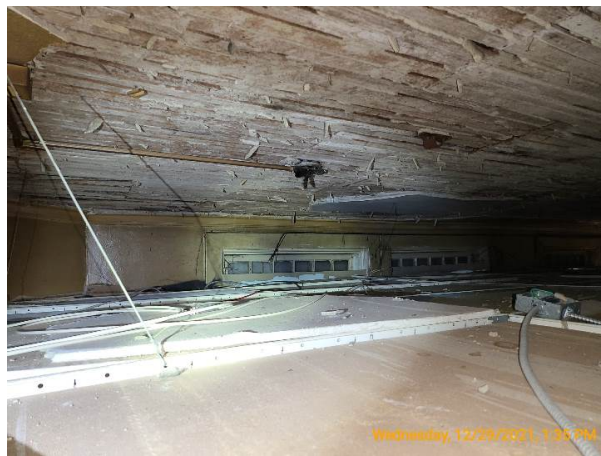
Significant ceiling tile damages throughout the entire first floor

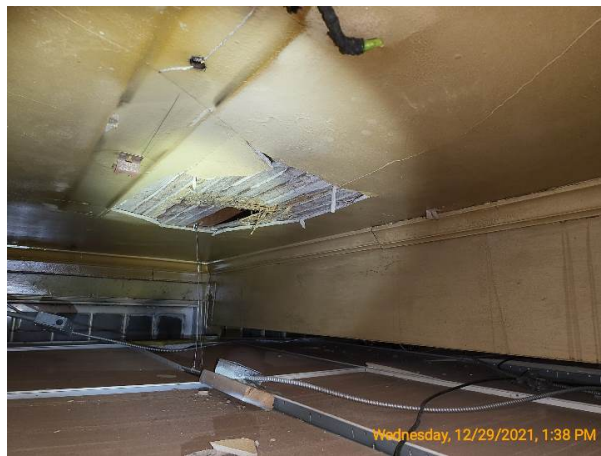
Significant damages at a right side beam 714

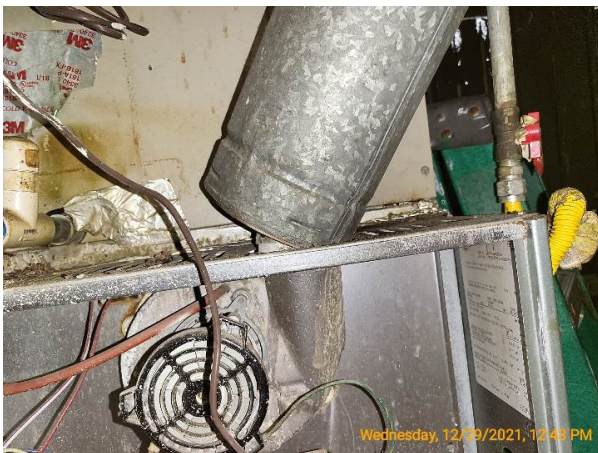
Inoperable gas furnace and coil over 10 years old

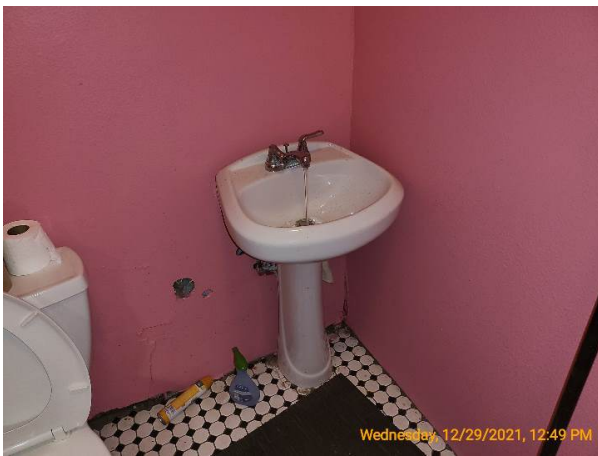
Water flow reversed

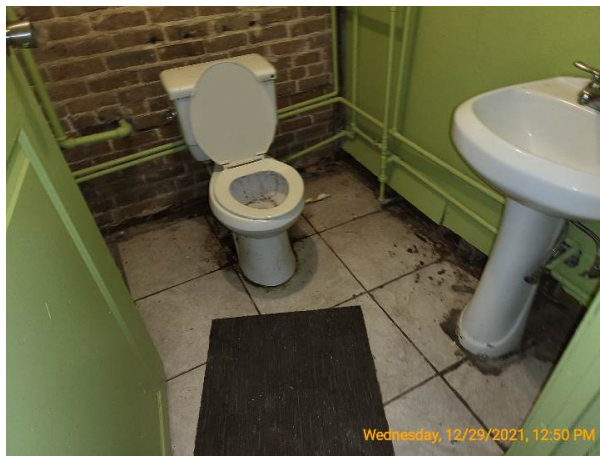
Loose sink in the women's restroom

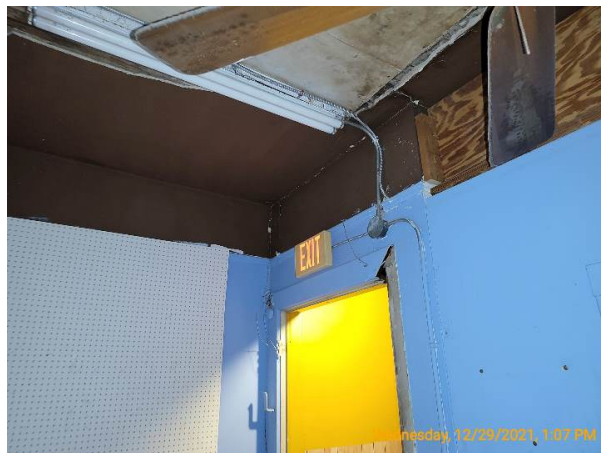
Significant moisture staining on the second floor ceiling

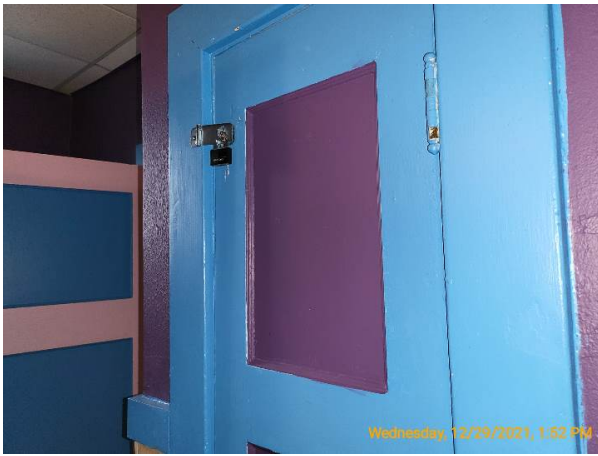
Broken fixture

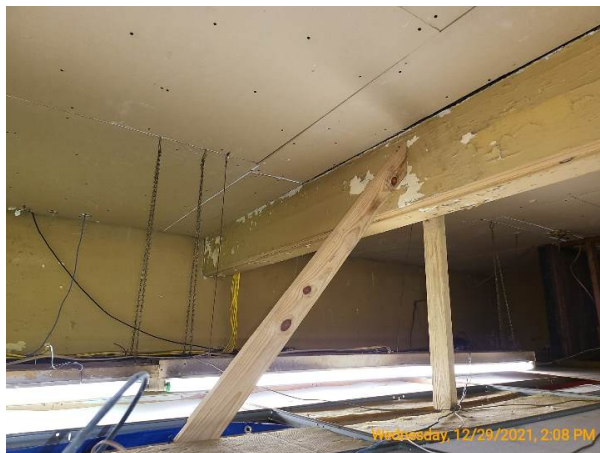
Significant deflection and split baseboard over the tattoo place, indicative of hidden beam damage

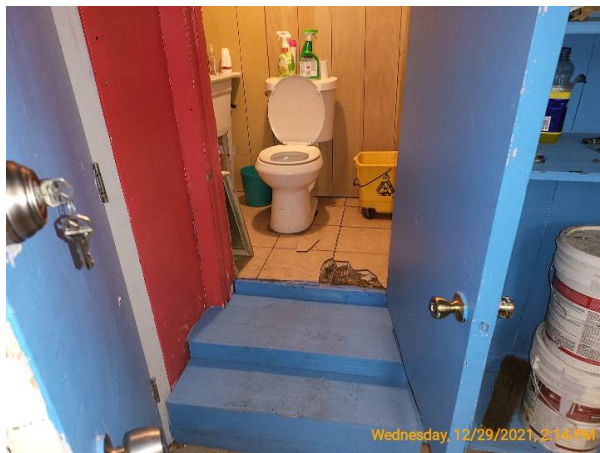
Damaged floor bathroom
