COMPASS INSPECTION SERVICES, LLC

504-833-0888

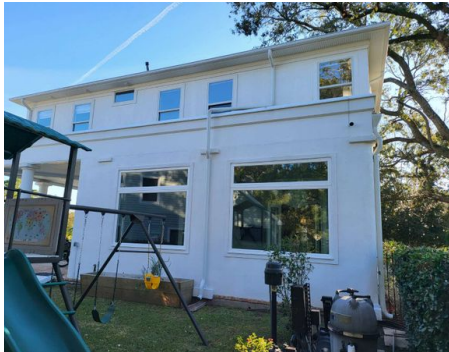
The sides of the building with stucco face in the above noted general direction.

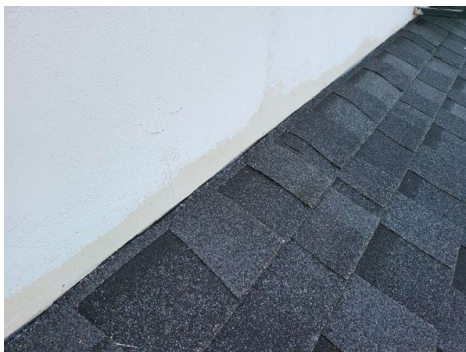
Close up showing different colored  
stucco at the front porch area that is  
indicative of a past repair

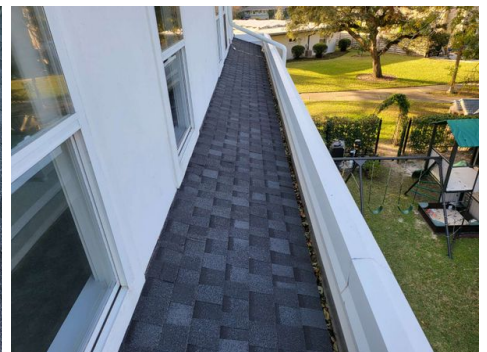
Right side Roofing detail

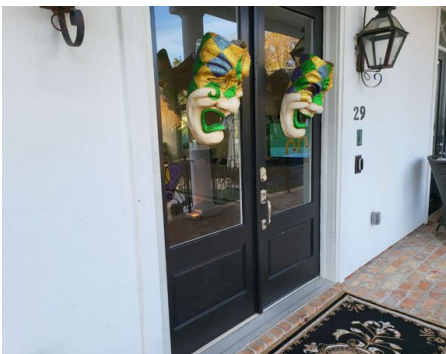
## Notable observations

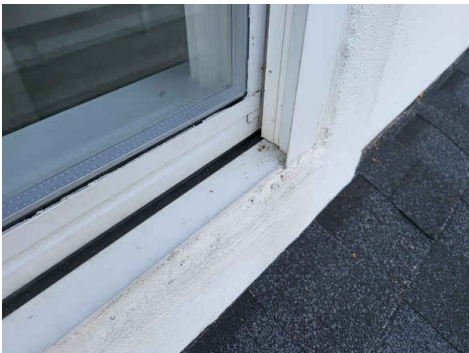
Older windows with miter joints

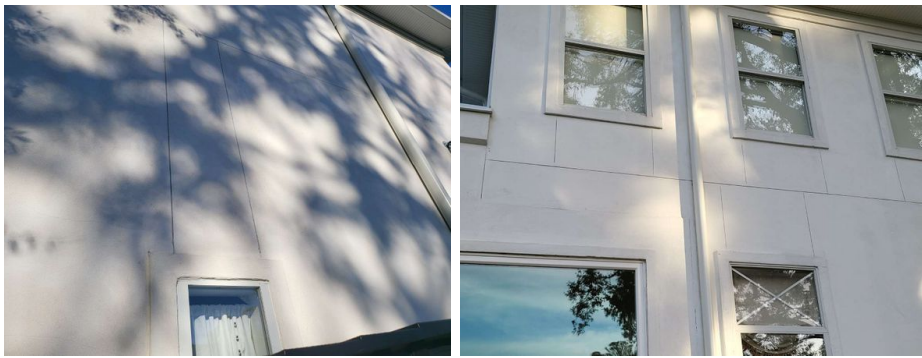
#### **GENERAL STUCCO: EXPANSION JOINT**

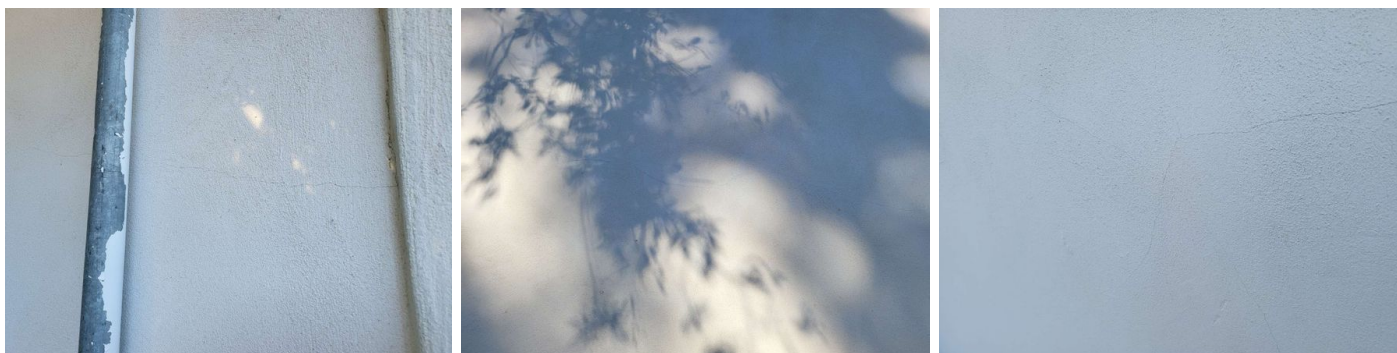
## CONDITIONS: SOFFIT PROTECTED

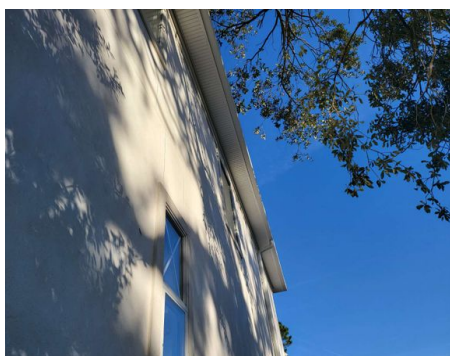
**CONDITIONS: TERMINATES MONOLITHIC FRONT PORCH**

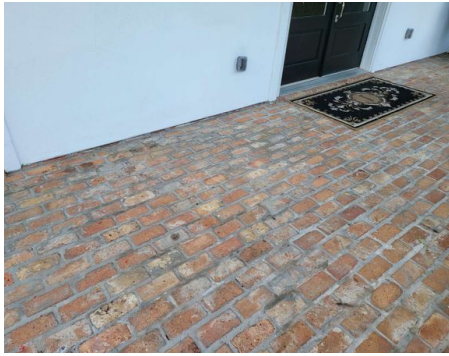
**CONDITIONS: SPRINKLER SYSTEM**

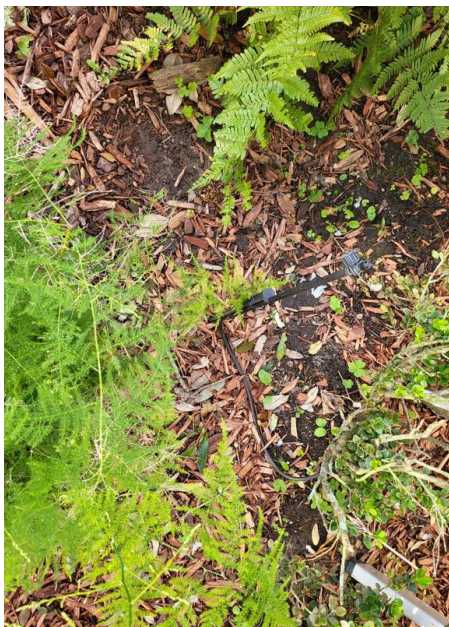
**CONDITIONS: PAST REPAIRS**

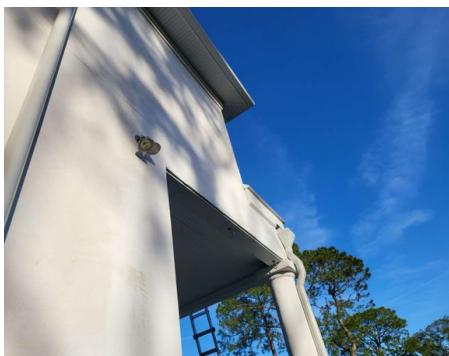
Based on the color difference in the stucco it appears that repairs were done to the front porch beams

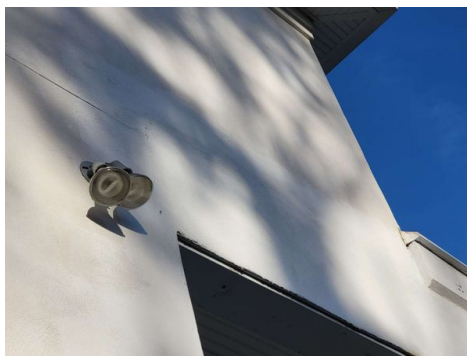
Close-up prior photo trying to show different color at the beams

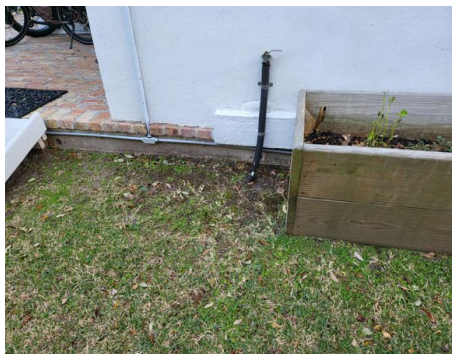
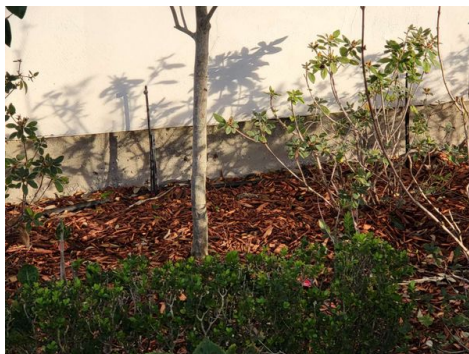
**FLASHINGS: VISIBLE AT ROOF**

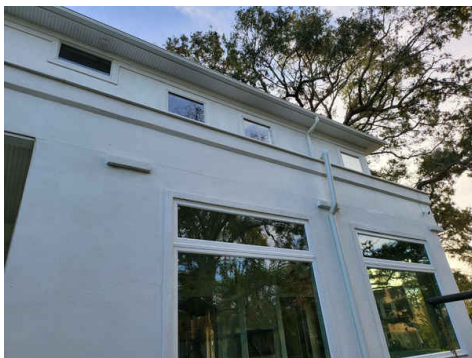
Grind crack and seal between first floor wall and second floor roof wall junction

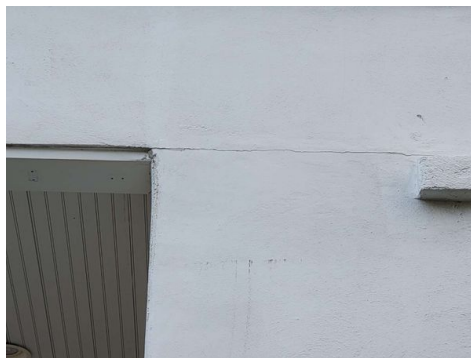
Close-up showing the location of the crack

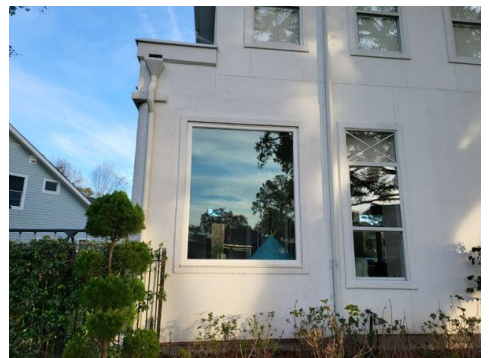
Grind crack and seal at the right rear corner of the house at what looks like an enclosed porch

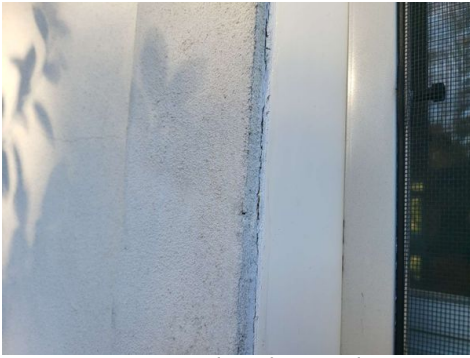
Separations noted at the window sealant

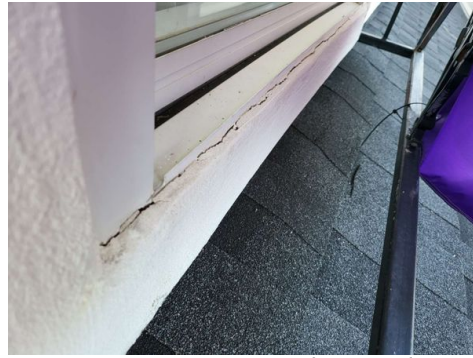
More separations at another window

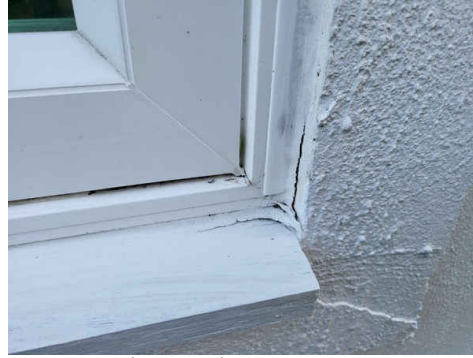
More window sealant separation

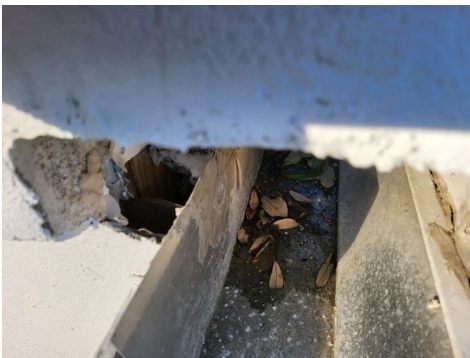
Large hole in the stucco at the left front corner should be waterproof

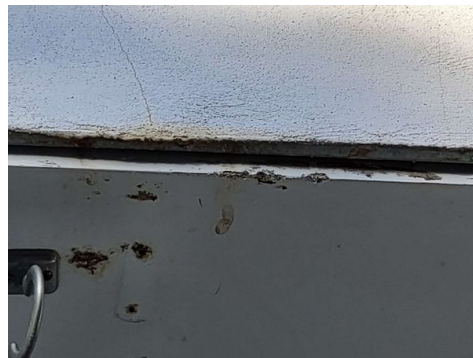
Chronic calcification at the base of the stucco and moisture staining on the wood trim below the left side beam, we recommend removal of the trim to evaluate the beam

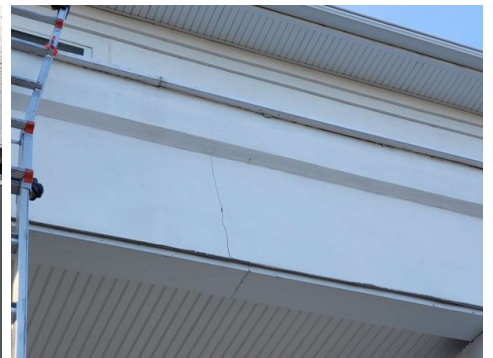
Notable crack over the front stairs and we recommend removal of the trim to evaluate the beam

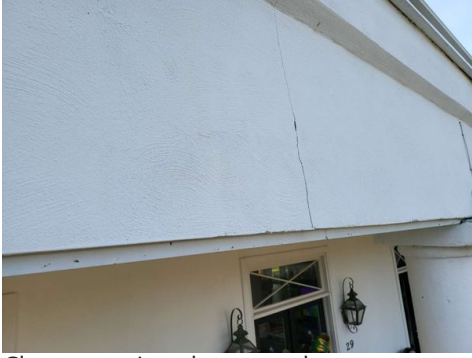
Close up prior photograph

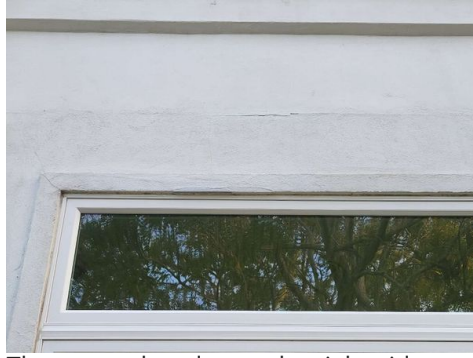
The accent band over the right side rear window is damaged
