On Site Photos

New Orleans, Louisiana

Wednesday, December 29, 2021

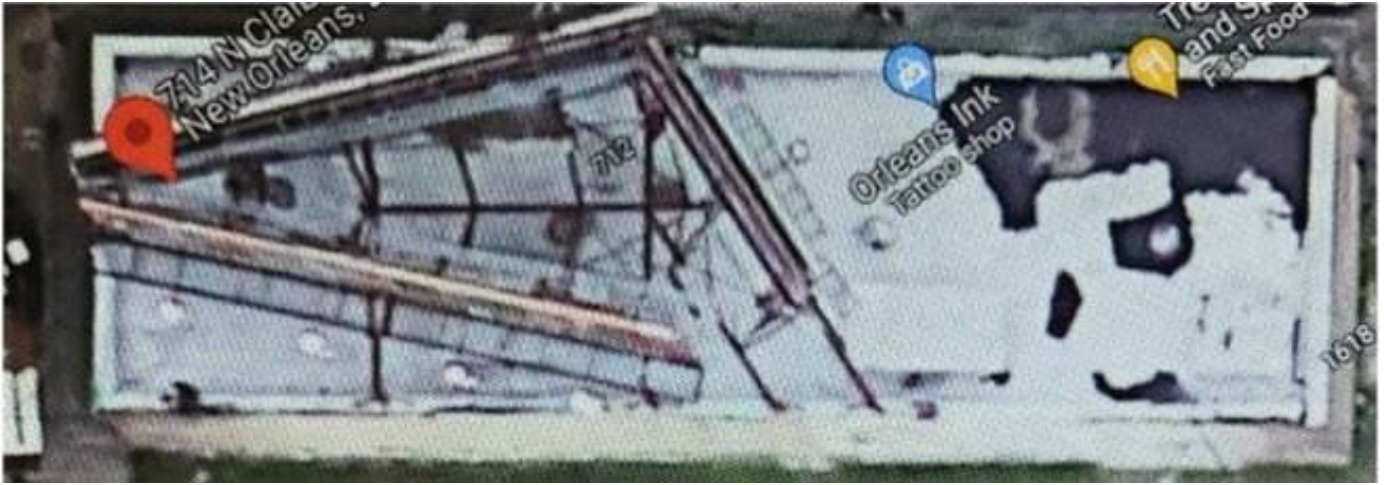
Overhead view - Building appears to sit on the property lines

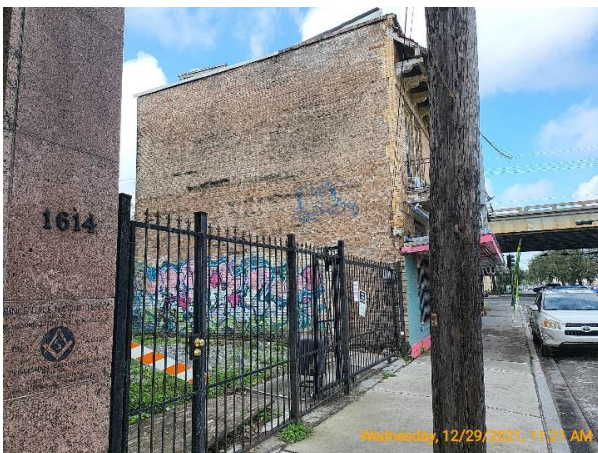
The rear of the building

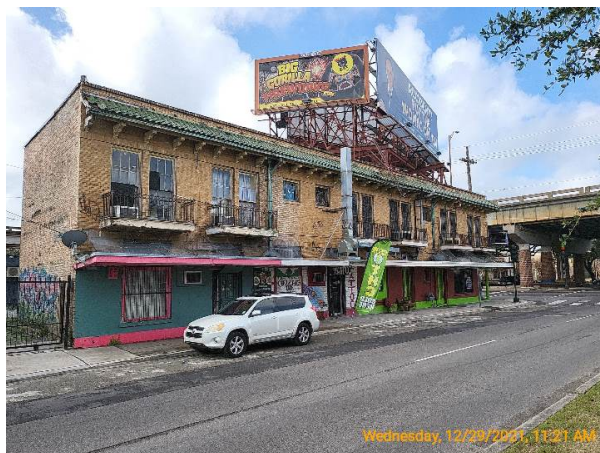
The left side of the building

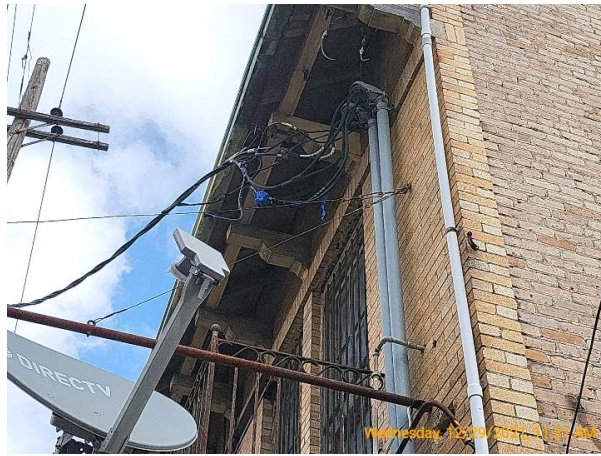
Main electrical entry point at the right front corner

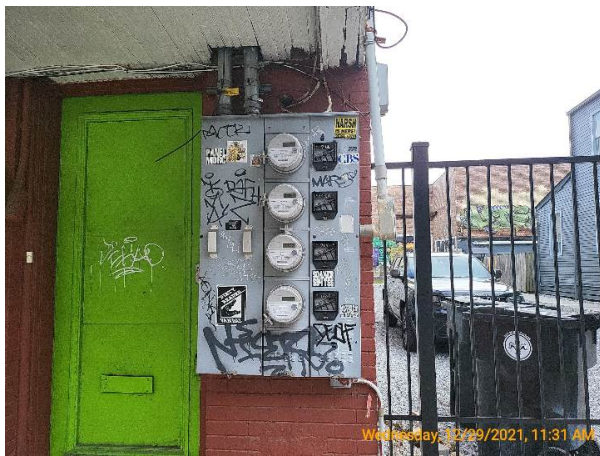
Four electric meters at the right front corner with service disconnects

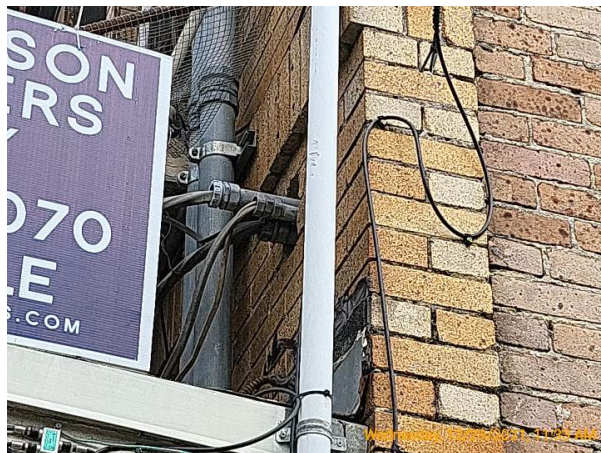
Electrical wires are not in conduit at the right front corner

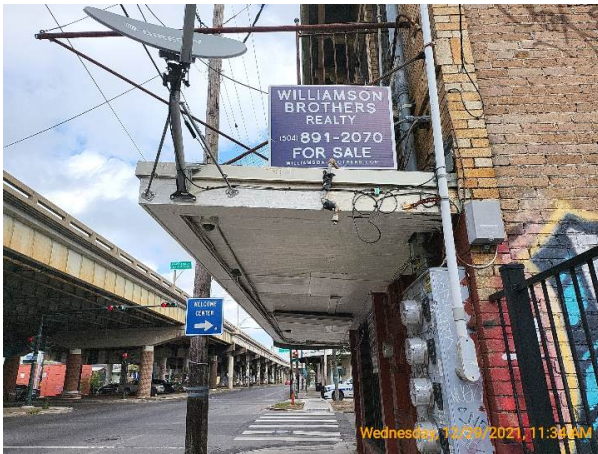
Sidewalk overhang has a negative slope across the front

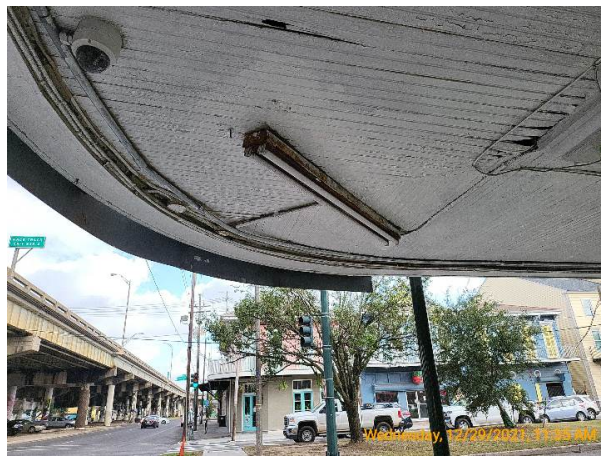
Overhang lighting was not functional

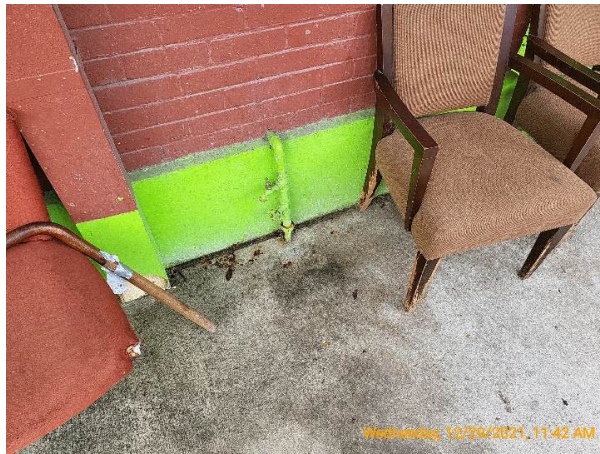
Single water meter enters at the left side

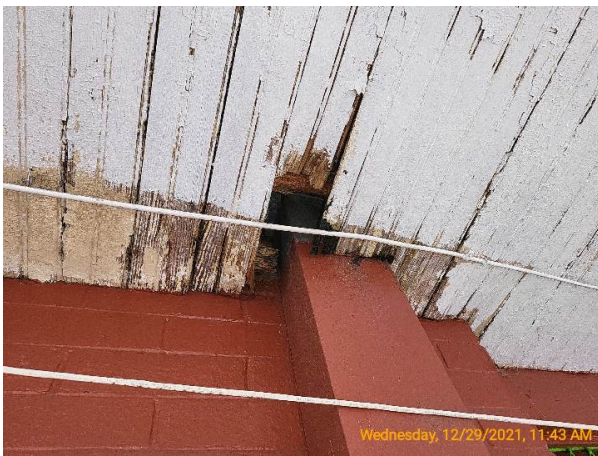
Significant wood rot below the sidewalk overhang

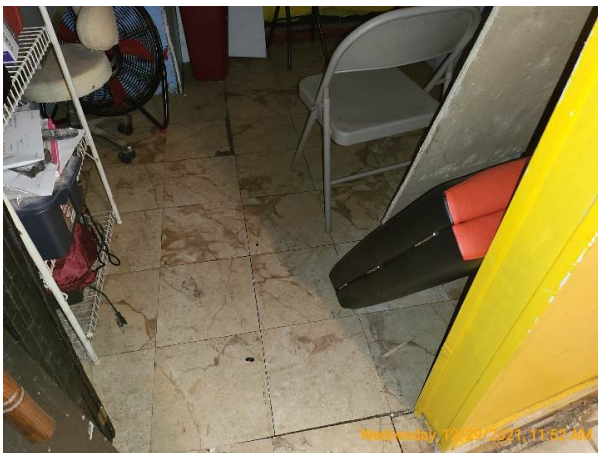
Raised wood floor rotted

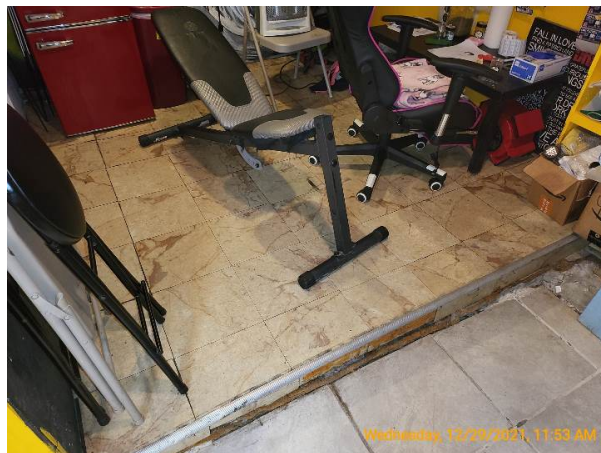
Another raised wood floor rotted through

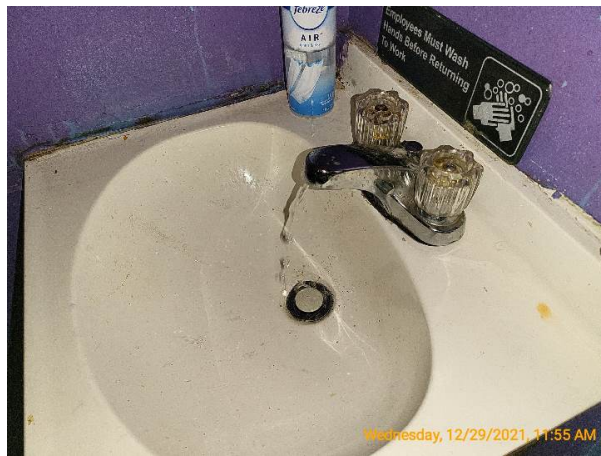
Severely low water flow in the half bathroom

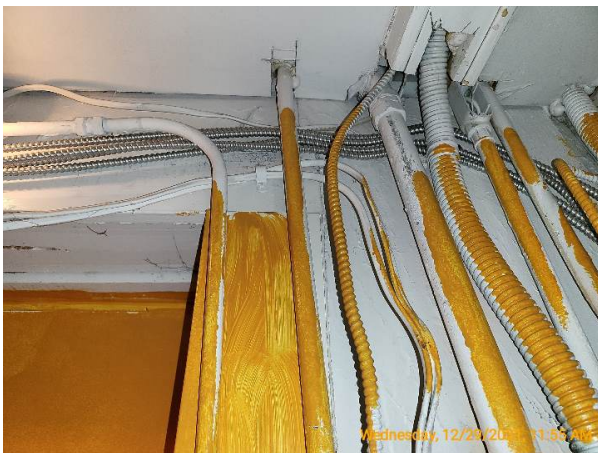
Exposed electrical wire

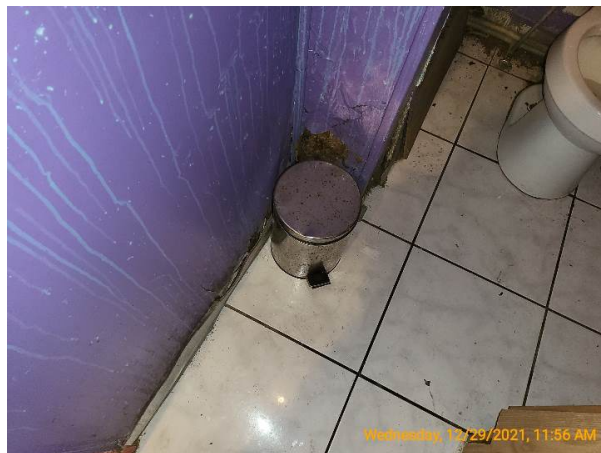
Severe moisture damage and possible mold growth at the base of the half bathroom wall

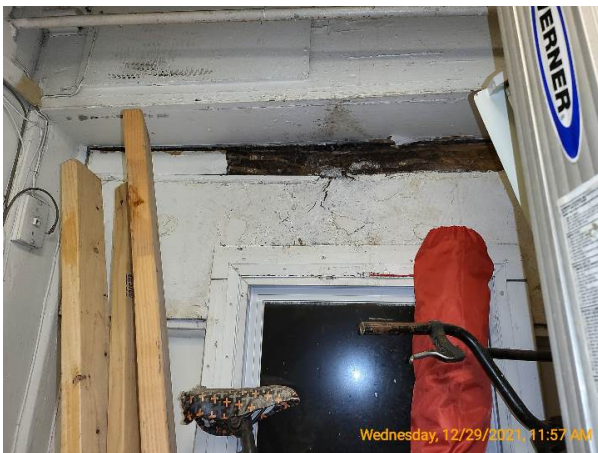
Severe moisture damages and rotted wood at the filled in cased opening at the equipment closet

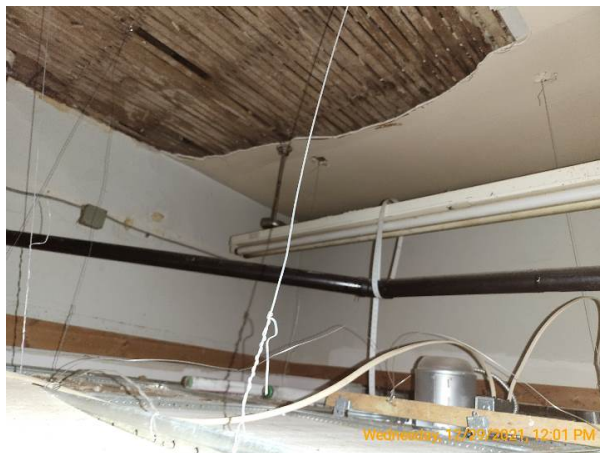
Drop down ceiling marginally supported, plaster prevents view of beams

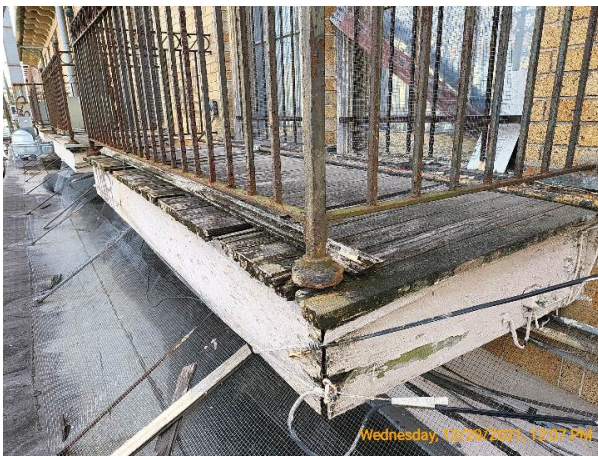
All balcony roofs are in poor condition

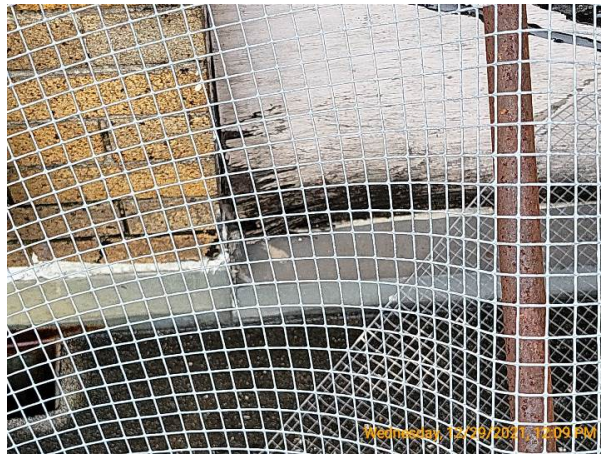
Rotted wood panels at masonry openings

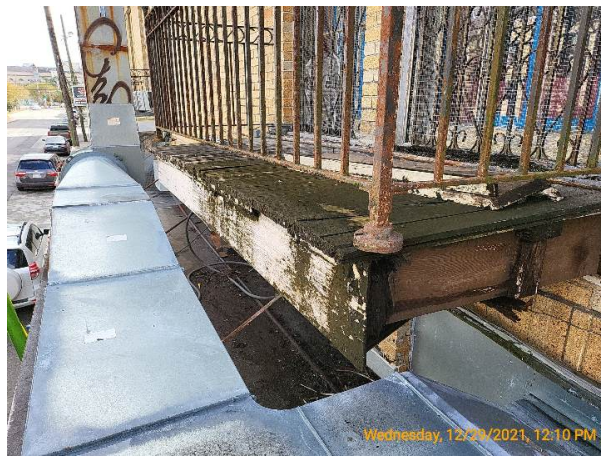
A left side balcony is notably out of square and structurally failing

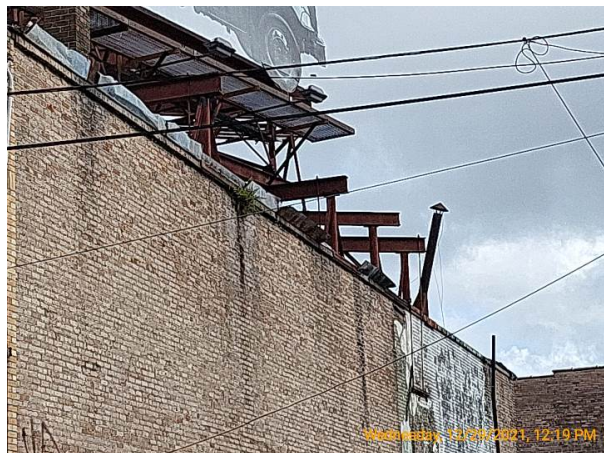
Severe vegetation growth along the right side

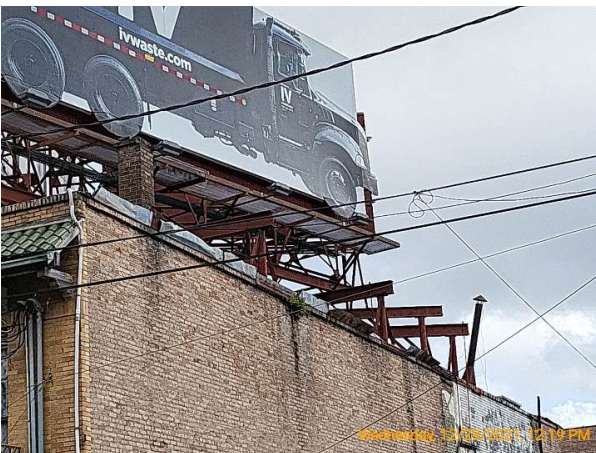
Metal parapet cap along the right side are bent upwards and significantly damaged

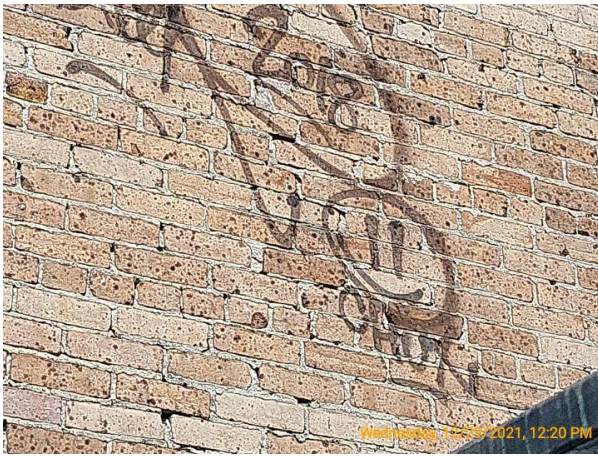
Numerous holes in the mortar were noted along the right side

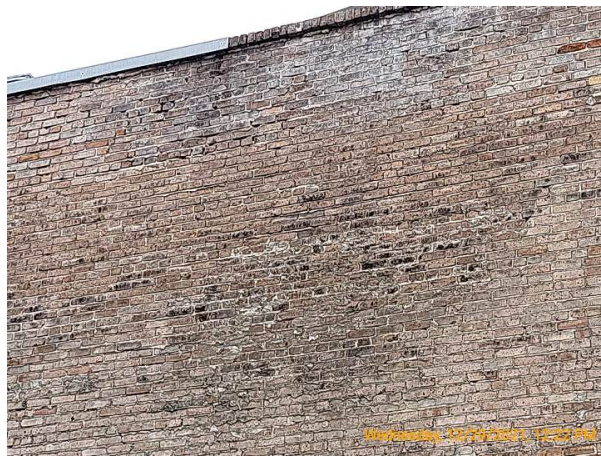
Numerous holes were noted in the mortar in the rear wall

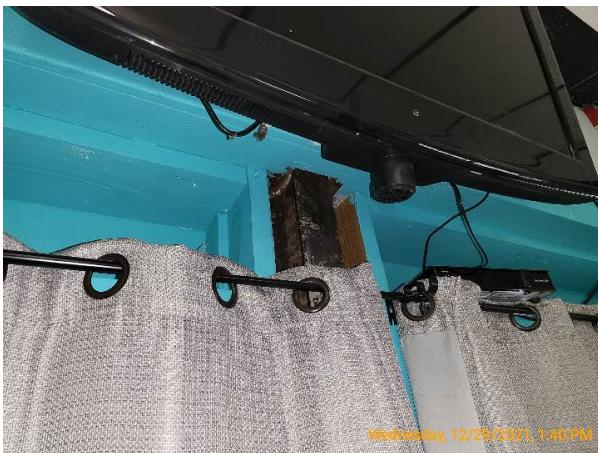
Steel post at the central front wall supporting the beam in 714

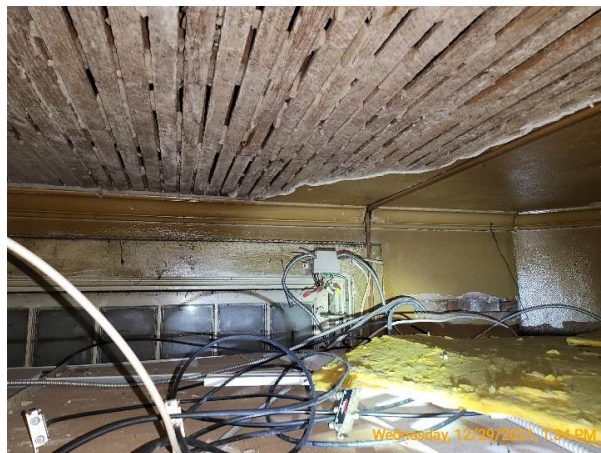
Open junction box

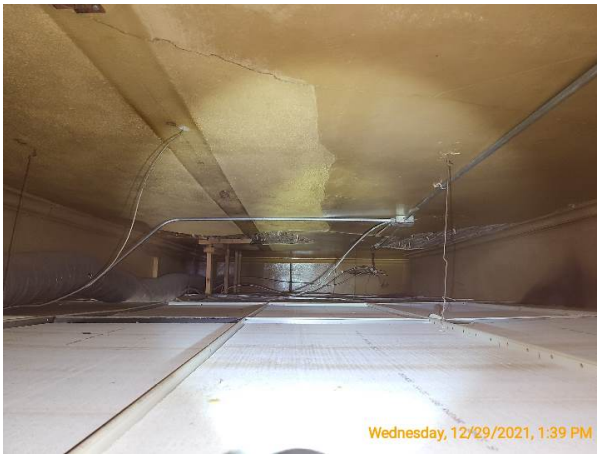
Plaster covers most of the right half ceiling of 714

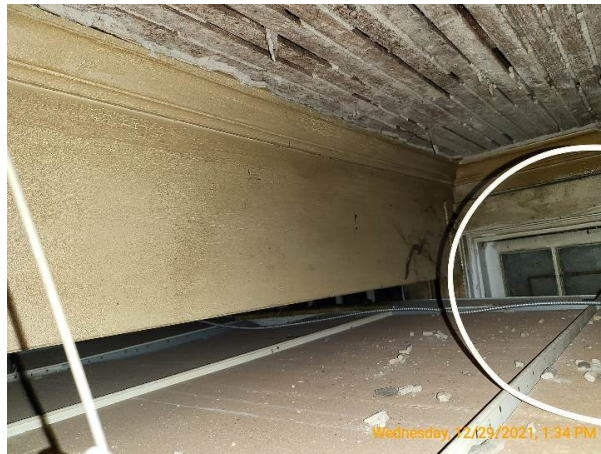
Central beam 714 appears functional

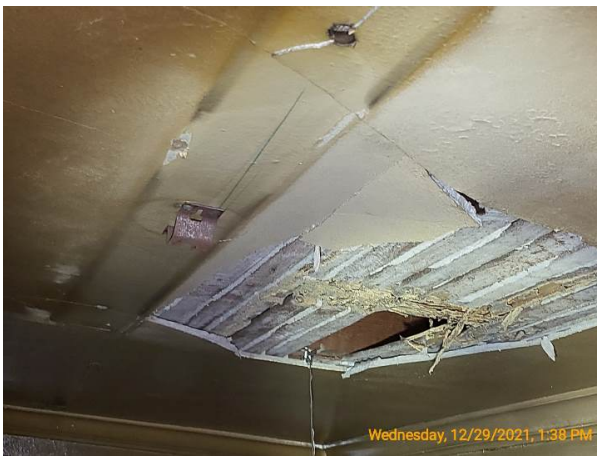
Significant damages at a right side beam 714

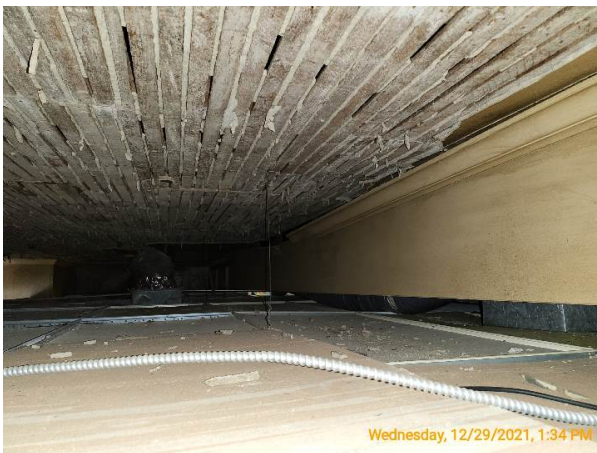
Central beam 714 appears functional

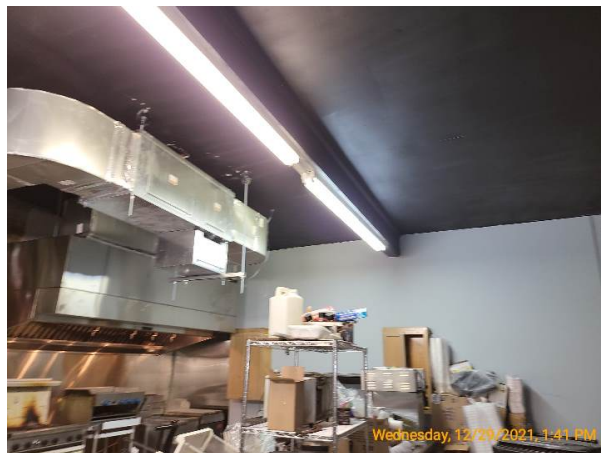
Plaster ceiling intact at the rear half of 714 and no visible beams

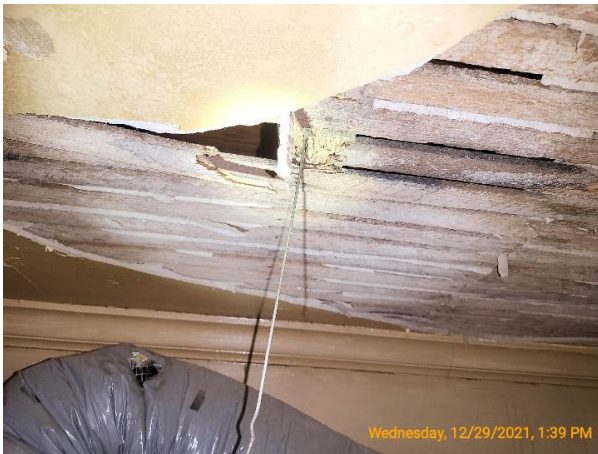
Significant damages at a third beam over the right half of 714

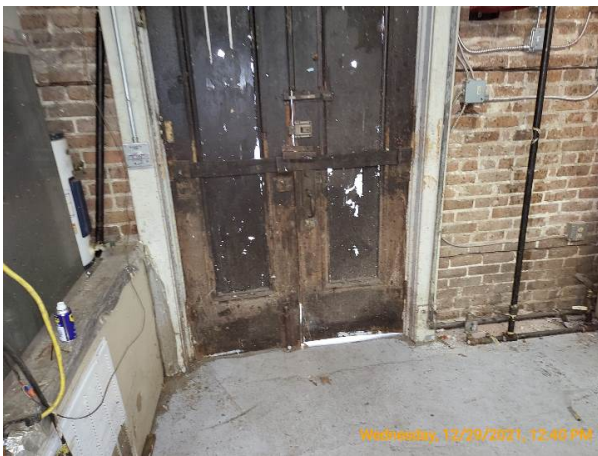
Another damaged door

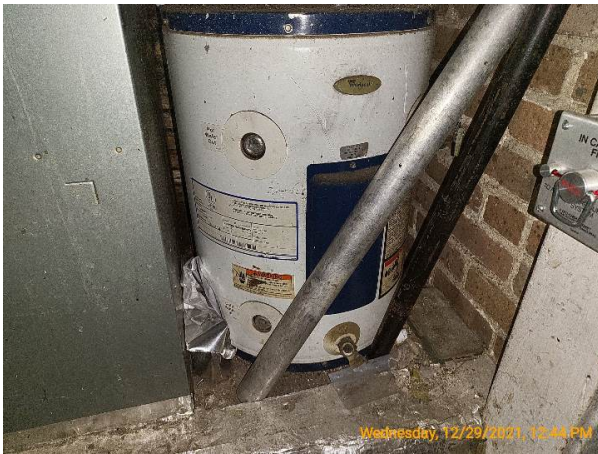
12 gallon electric water heater manufactured in 2008, functional

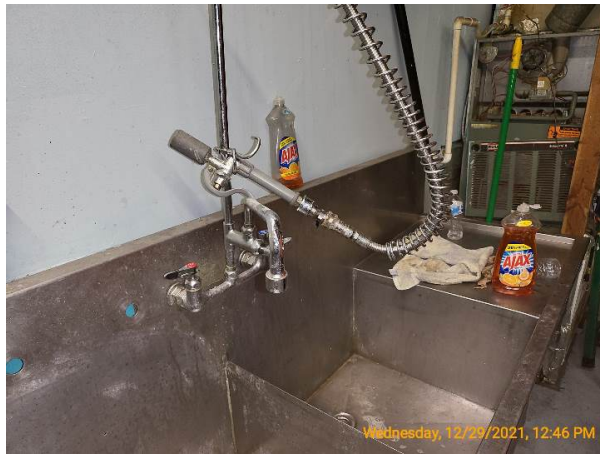
Water flow reversed

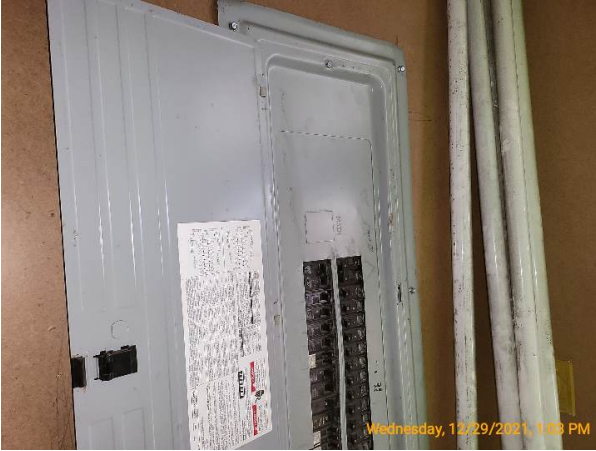
Sub panel for unit 714, we did not have a driver to remove the cover

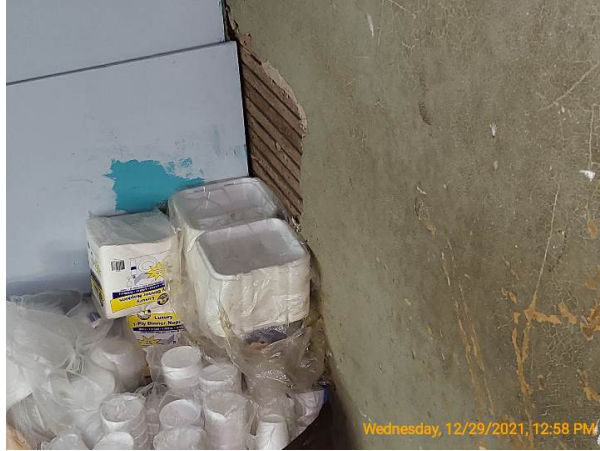
Missing plaster throughout the exterior walls

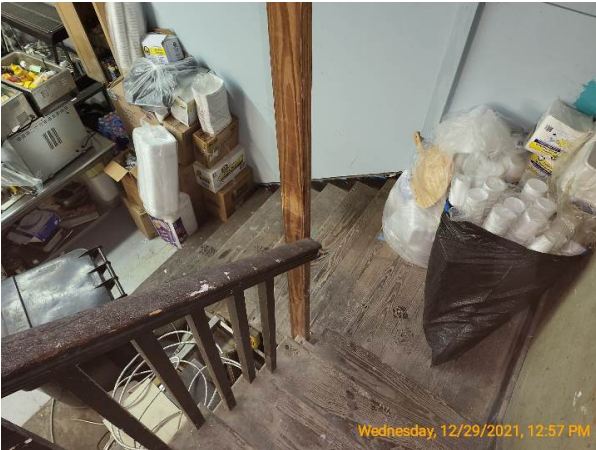
Loose railing and missing railing at the stairs to the second floor

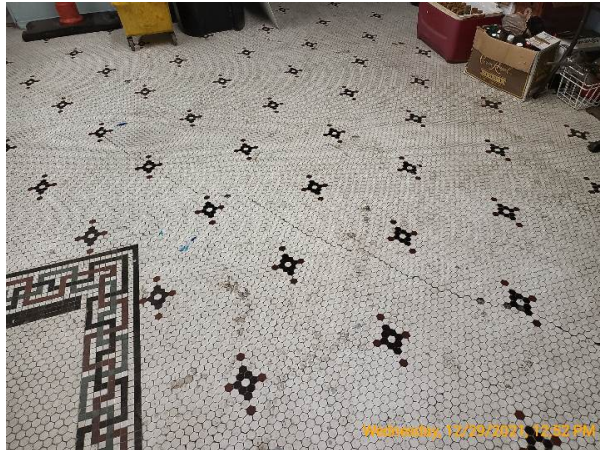
Typical cracking in the floating slab

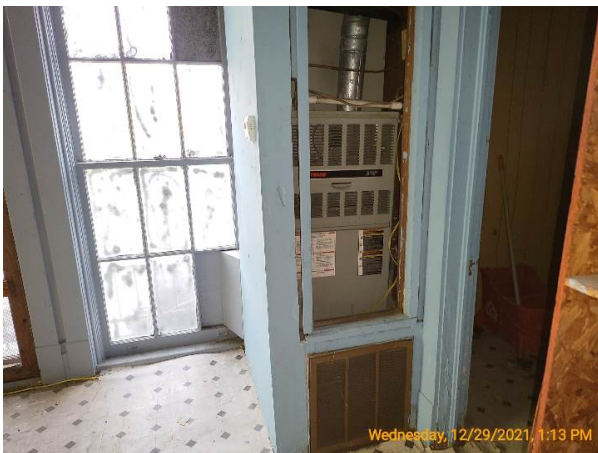
Inoperable furnace and heater that appears to be over 15 years old

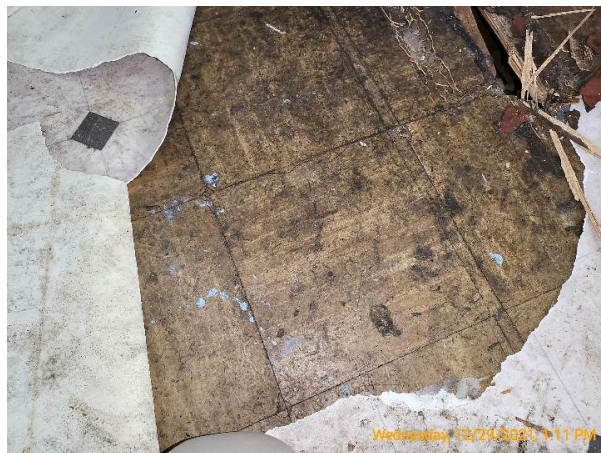
Possible asbestos tiles under the vinyl floor

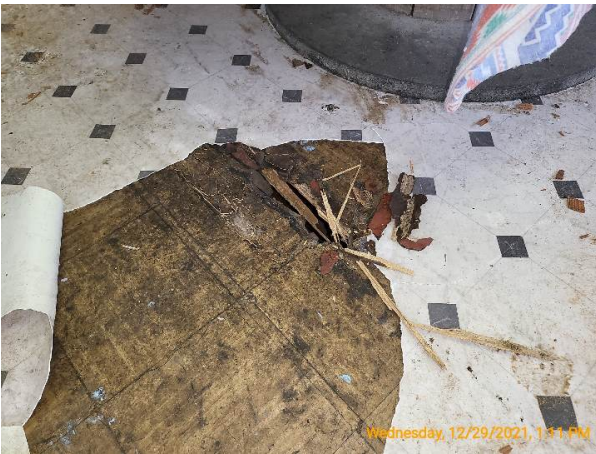
Significant subfloor and visible framing damages at the left front corner of the building

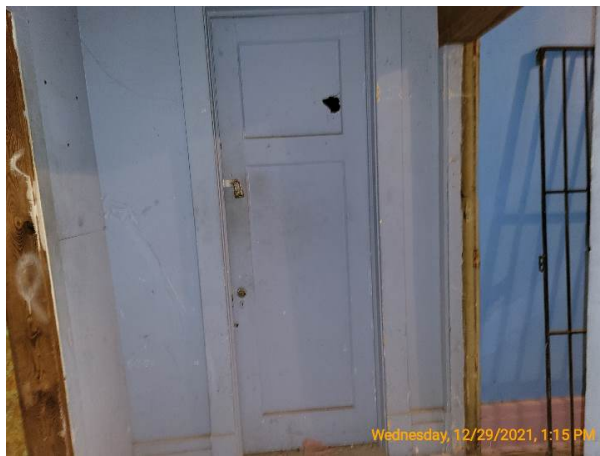
Inaccessible closet opposite the bathroom after front

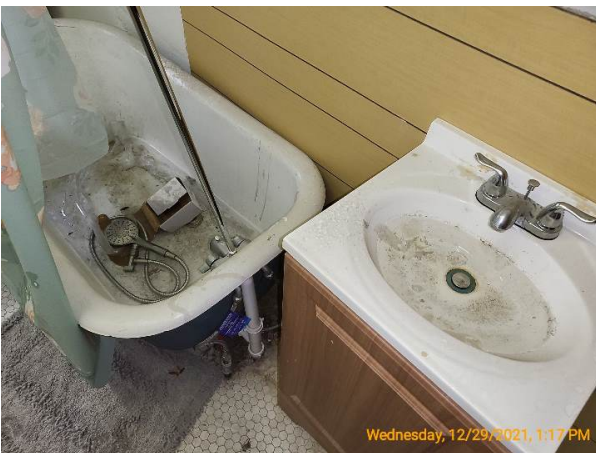
Slow drain at the rear bathroom sink and tub

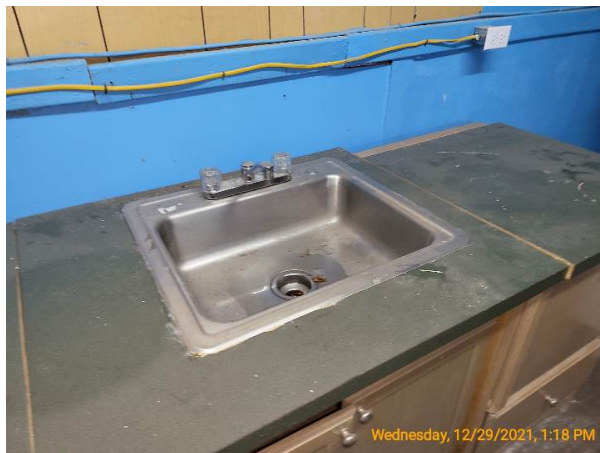
Kitchen sink has a slow drain

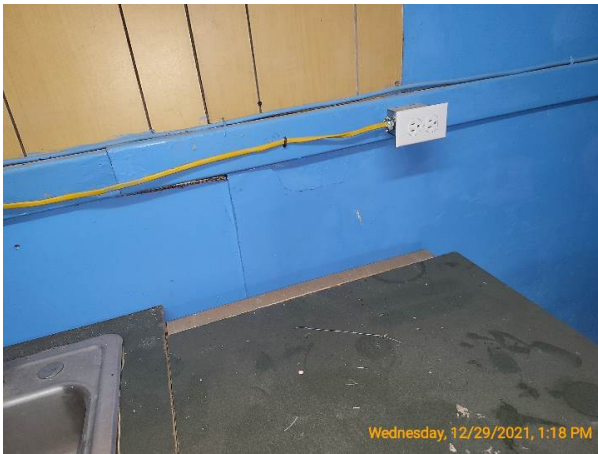
Newer electrical wiring not in conduit

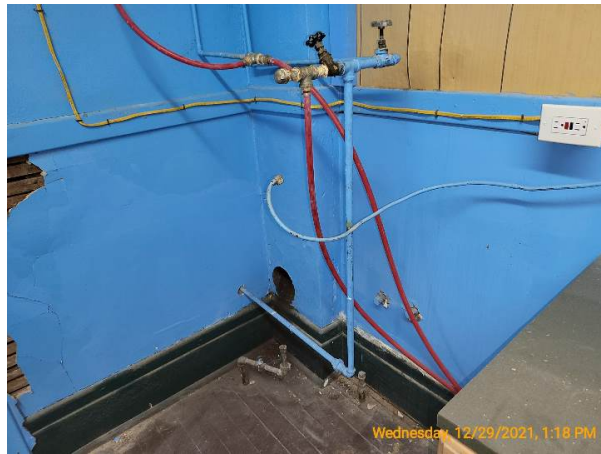
Water heater not installed

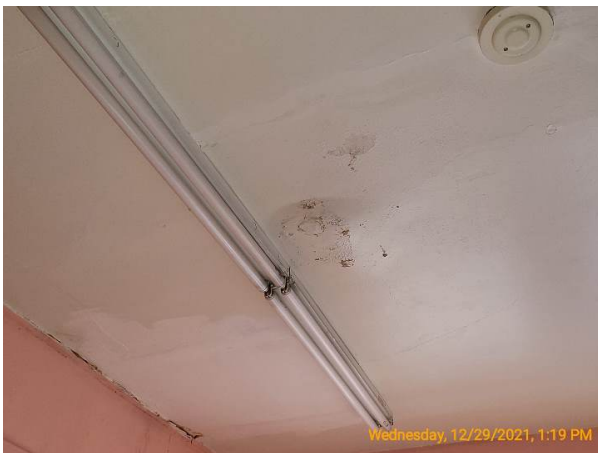
Evidence of active leakage at a left side bedroom and between the two bedrooms

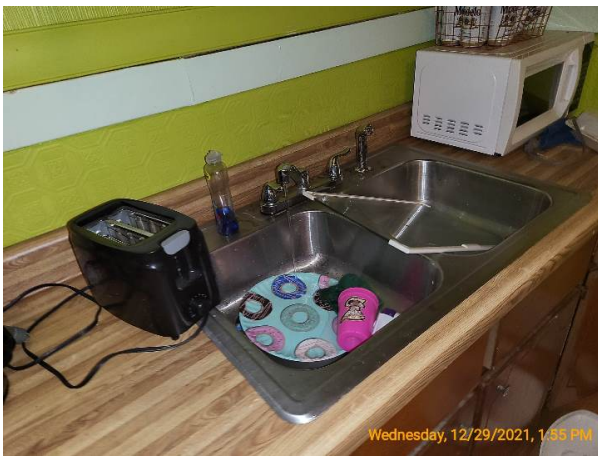
Severely low water flow

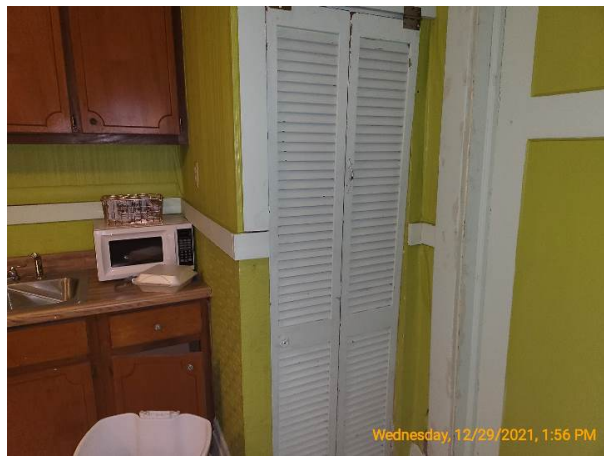
Gas water heater is not accessible

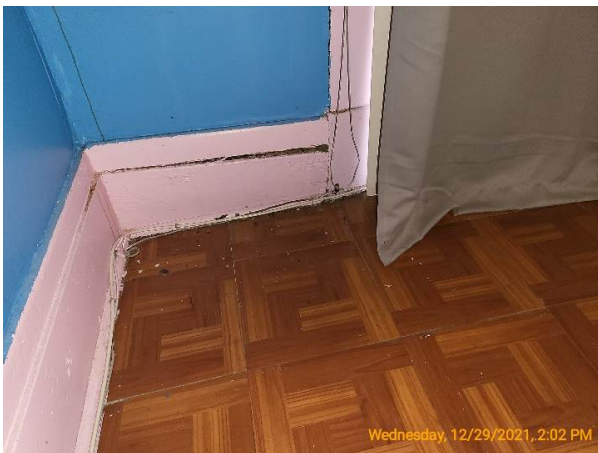
Significant deflection and split baseboard over the tattoo place, indicative of hidden beam damage

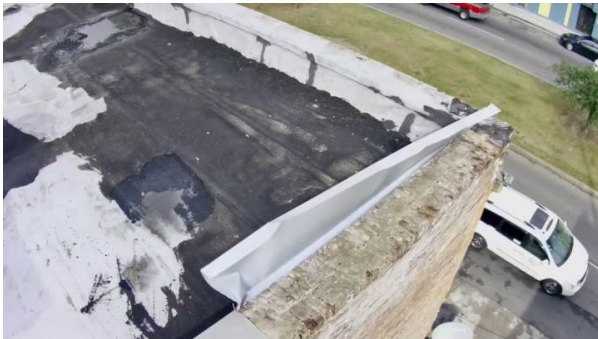
Damaged parapet cap

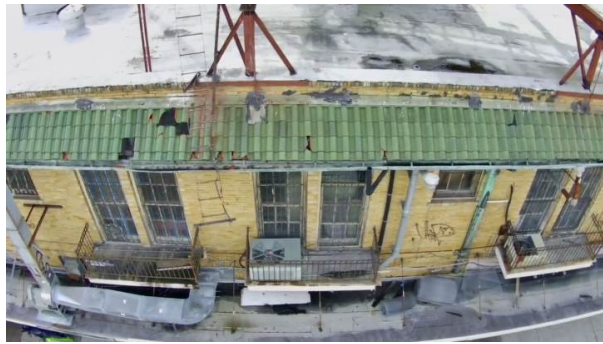
Terra cotta tile roof missing numerous tiles
