On Site Photos

New Orleans, Louisiana

Wednesday, December 29, 2021

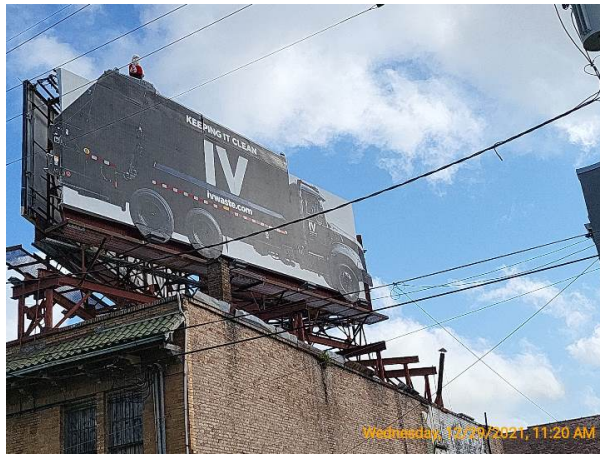
Billboard over the roof at the right side of the building

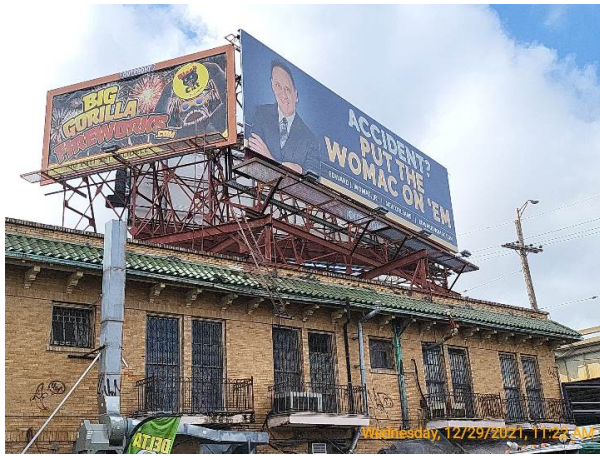
Billboard over the building as you look from the left side

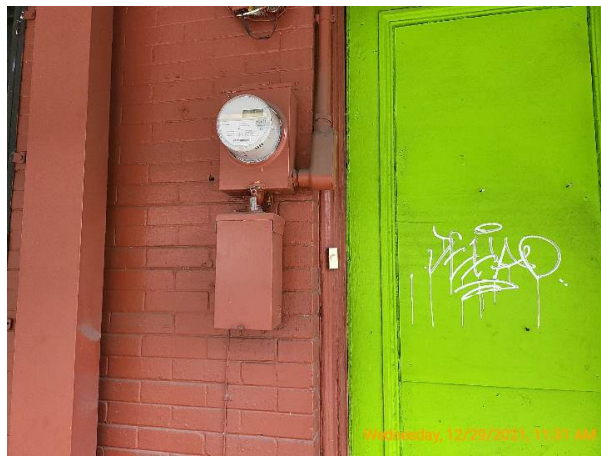
Fifth meter at the right front corner

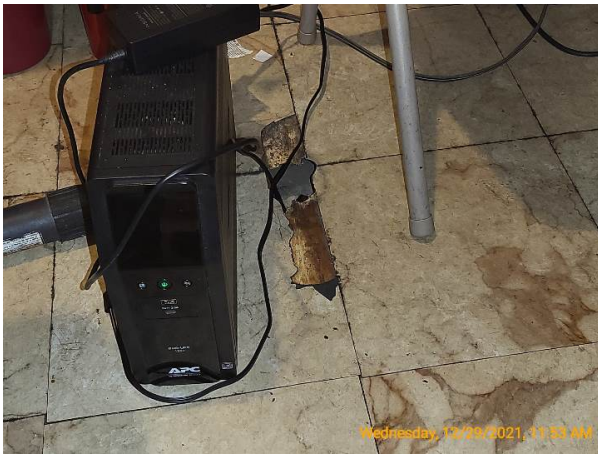
Close up

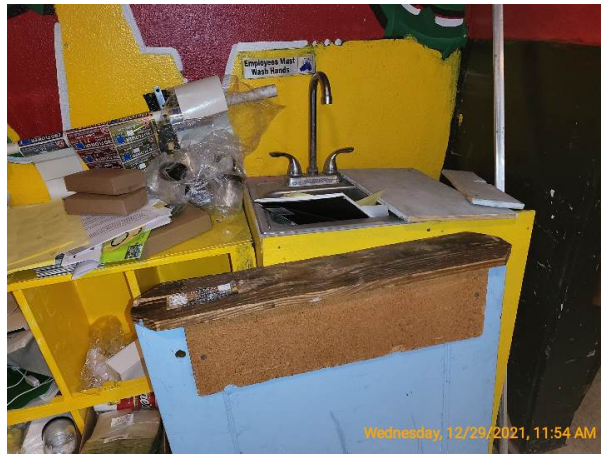
Inoperable sink

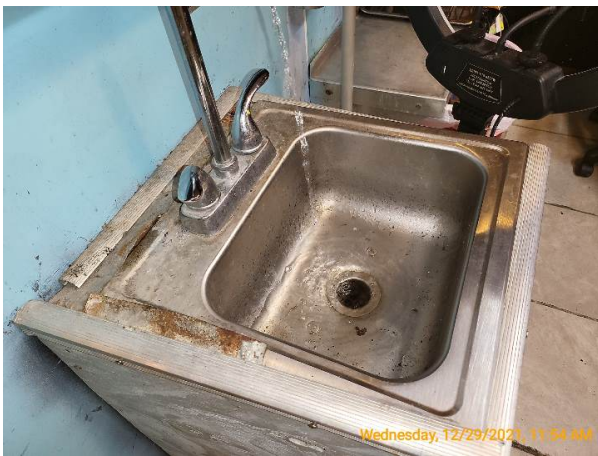
Slow drain at another sink

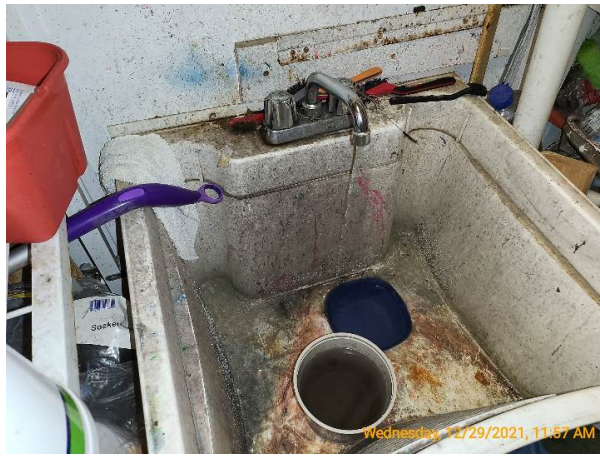
More severe low water flow

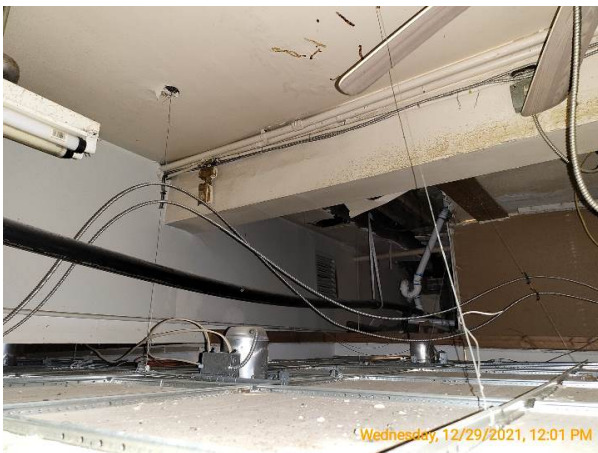
Drop down ceiling marginally supported, plaster prevents view of beams

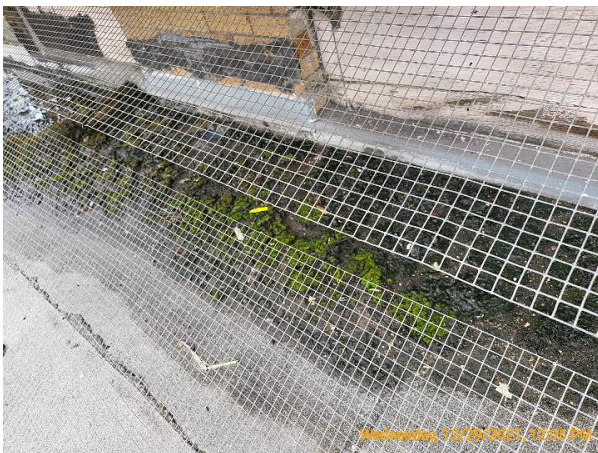
Close-up

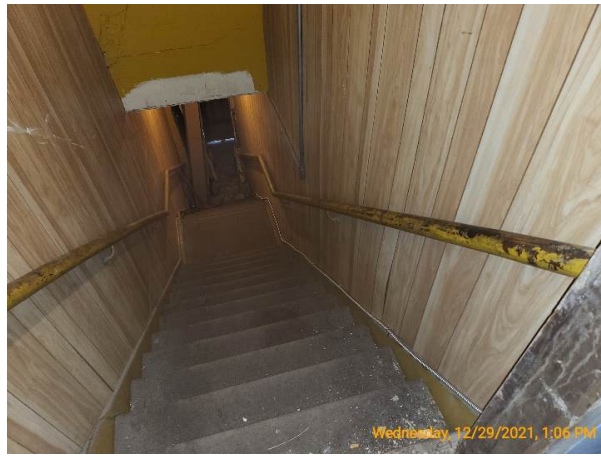
Loose rails

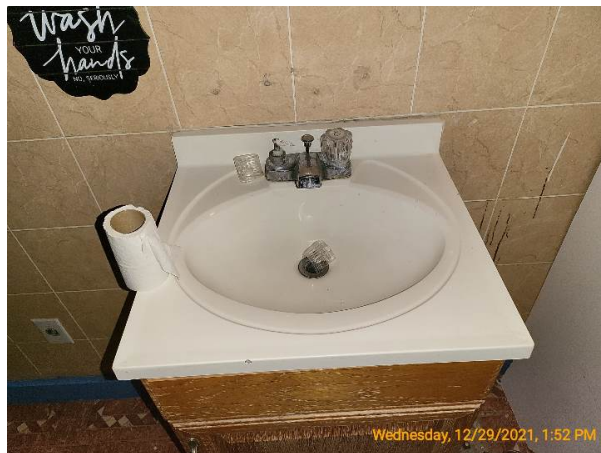
Broken fixture
